New Hampshire Volunteer Lake Assessment Program

2002 Bi-Annual Report for Governors Lake Raymond

NHDES
Water Division
Watershed Management Bureau
6 Hazen Drive
Concord, NH 03301

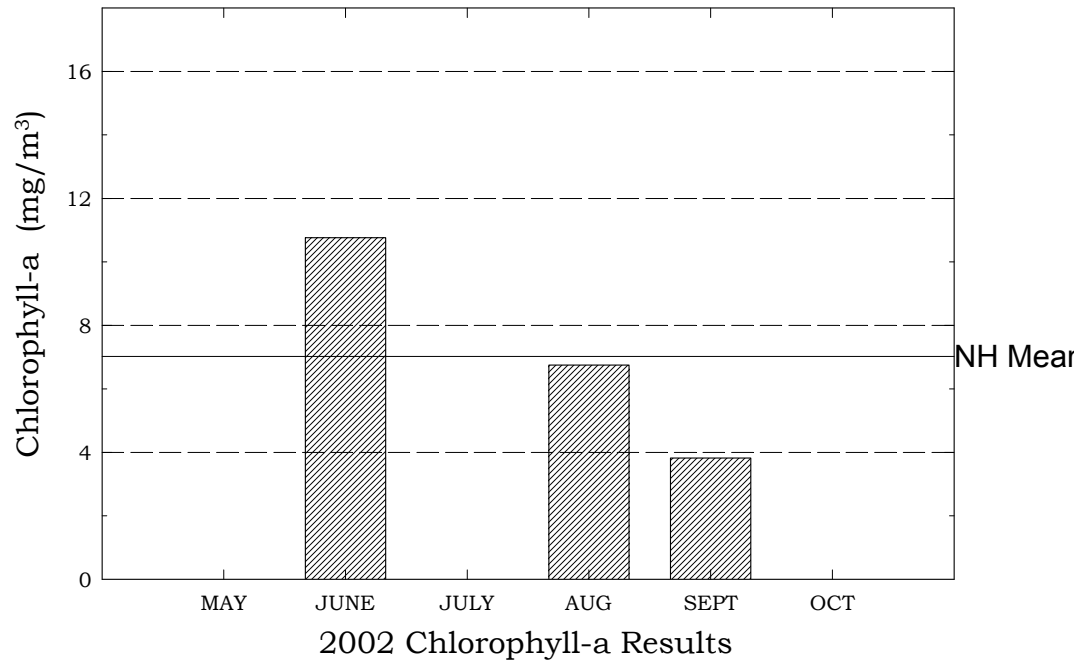
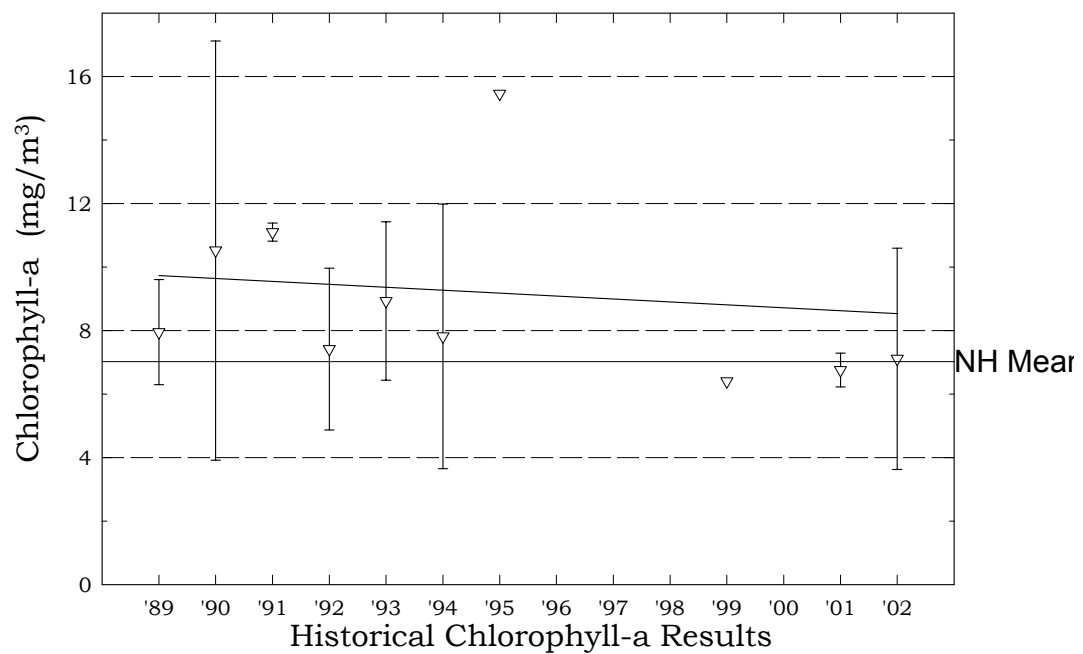
Figure 1. Monthly and Historical Chlorophyll-a Results

- **Figure 1 and Table 1:** The graphs in Figure 1 (Appendix A) show the historical and current year chlorophyll-a concentration in the water column. Table 1 (Appendix B) lists the maximum, minimum, and mean concentration for each sampling season that the lake/pond has been monitored through the program.

The current year data (the top graph) show that the chlorophyll-a concentration ***steadily decreased*** from June to September. The chlorophyll-a concentration in June was ***much greater than*** the state mean.

The historical data (the bottom graph) show that the 2002 chlorophyll-a mean is ***approximately equal to*** the state mean.

Overall, visual inspection of the historical data trend line (the bottom graph) shows **a slightly decreasing** in-lake chlorophyll-a trend, meaning that the concentration has **slightly improved** since monitoring began in 1989.

While algae are naturally present in all lakes/ponds, an excessive or increasing amount of any type is not welcomed. In freshwater lakes/ponds, phosphorus is the nutrient that algae depend upon for growth. Therefore, algal concentrations may increase when there is an increase in nonpoint sources of nutrient loading from the watershed, or in-lake sources of phosphorus loading (such as phosphorus releases from the sediments). It is important to continually educate residents about how activities within the watershed can affect phosphorus loading and lake quality.

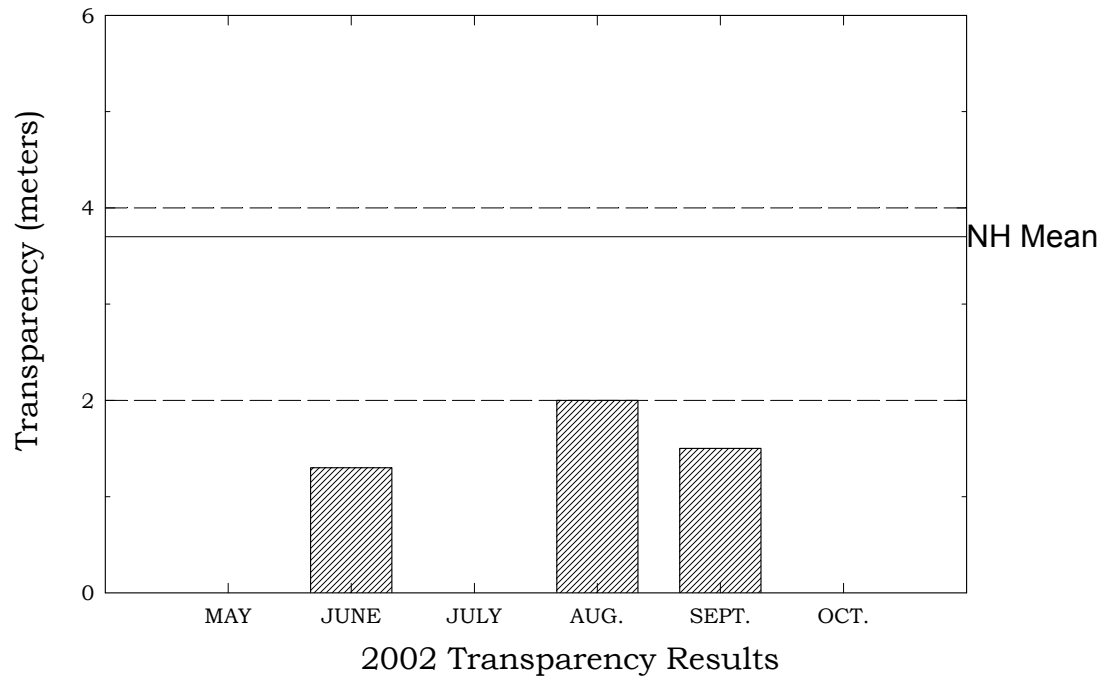
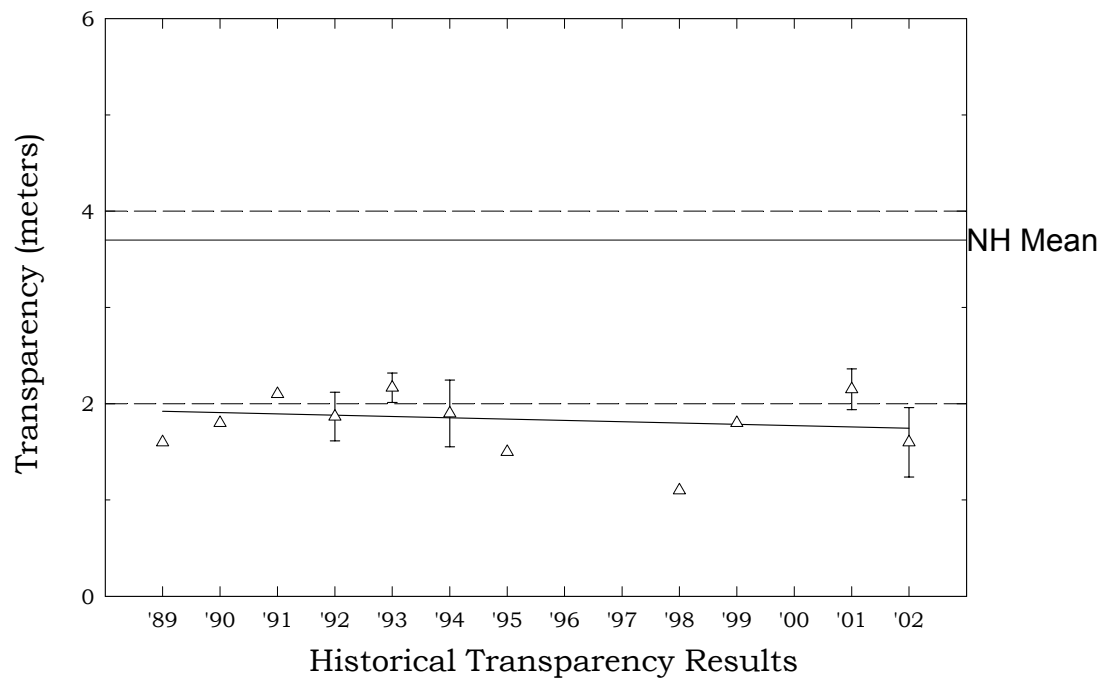
Figure 2. Monthly and Historical Transparency Results

- **Figure 2 and Table 3:** The graphs in Figure 2 (Appendix A) show historical and current year data for lake/pond transparency. Table 3 lists the maximum, minimum and mean transparency data for each sampling season that the lake/pond has been monitored through the program.

The current year data (the top graph) show that the in-lake transparency **increased** from June to August, and then **decreased slightly** from August to September.

Overall, visual inspection of the historical data trend line (the bottom graph) shows **a relatively stable** trend for in-lake transparency, meaning that the transparency has **remained approximately the same** since monitoring began. Again, after 10 consecutive years of sample collection, we will be able to conduct a statistical analysis of the historic data to objectively determine if there has been a significant change in the annual mean transparency since monitoring began.

Typically, high intensity rainfall causes erosion of sediments into lakes/ponds and streams, thus decreasing clarity. Efforts should continually be made to stabilize stream banks, lake/pond shorelines, disturbed soils within the watershed, and especially dirt roads located immediately adjacent to the edge of tributaries and the lake/pond. Guides to Best Management Practices designed to reduce, and possibly even eliminate, nonpoint source pollutants, such as sediment loading, are available from NHDES upon request.

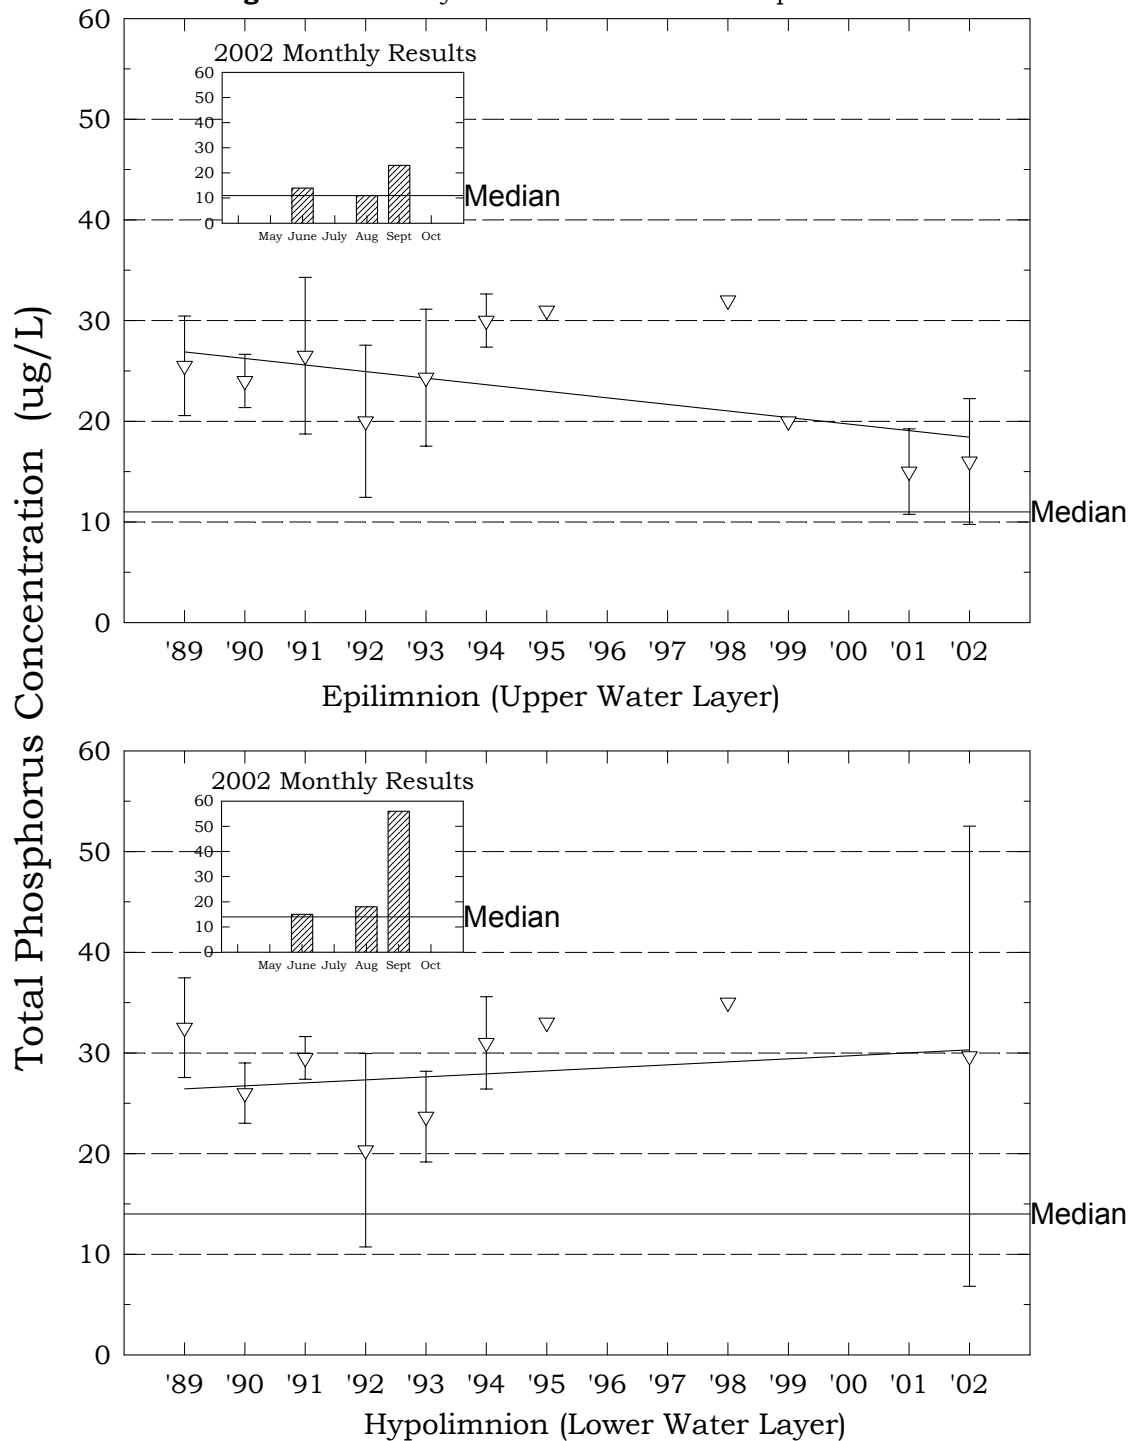
Figure 3. Monthly and Historical Total Phosphorus Data.

- **Figure 3 and Table 8:** The graphs in Figure 3 (Appendix A) show the amounts of phosphorus in the epilimnion (the upper layer) and the hypolimnion (the lower layer); the inset graphs show current year data. Table 8 (Appendix B) lists the annual maximum, minimum, and median concentration for each deep spot layer and each tributary since the lake/pond has joined the program.

The current year data for the epilimnion (the top inset graph) show that the total phosphorus concentration **decreased slightly** from June to August, and then **increased** from August to September.

The historical data show that the 2002 mean epilimnetic total phosphorus concentration is **greater than** the state median.

The current year data for the hypolimnion (the bottom inset graph) show that the total phosphorus concentration **increased gradually** from June to August, and then **increased by a large amount** from August to September. The total phosphorus concentration in September was **much greater than** the state median.

It is important to note that the turbidity of the hypolimnion (lower layer) sample was elevated on the **September** sampling event (**6.15 NTUs**). This suggests that the lake/pond bottom may have been disturbed by the anchor or by the Kemmerer Bottle while sampling. When the lake/pond bottom is disturbed, sediment, which typically contains attached phosphorus, is released into the water column. When collecting the hypolimnion sample, please check to make sure that there is no sediment in the Kemmerer Bottle before filling the sample bottles.

The historical data show that the 2002 mean hypolimnetic total phosphorus concentration is **much greater than** the state median.

Overall, visual inspection of the historical data trend line for the epilimnion show **a slightly decreasing** total phosphorus trend, which means that the concentration has **slightly improved** in the epilimnion since monitoring began in 1989.

Overall, visual inspection of the historical data trend line for the hypolimnion shows **a variable** total phosphorus trend, which means that the concentration has **fluctuated** in the hypolimnion since monitoring began. In addition, the mean annual total phosphorus concentration in the hypolimnion has been **much greater than** the state median since monitoring began.

Governor's Lake has had an elevated total phosphorus concentration in the hypolimnion for many years. Due to the relatively shallow depth of the lake and the generally high horsepower of boats on the lake, the Limnology Center Director believes that the elevated phosphorus concentration in the hypolimnion is likely partially due to boat traffic.

Since your lake/pond is relatively shallow, it is important to educate lake association members and lake-users on the importance of operating boats at headway speed in shallow areas to minimize disturbance to sediments and vegetation. Churning up the nutrient-laden bottom sediments promotes algae growth, increases turbidity, decreases clarity and is disruptive to benthic organisms.
